CAMBORNE LIBRARY

Public Engagement Event

Camborne Town Council

Building Repair Work

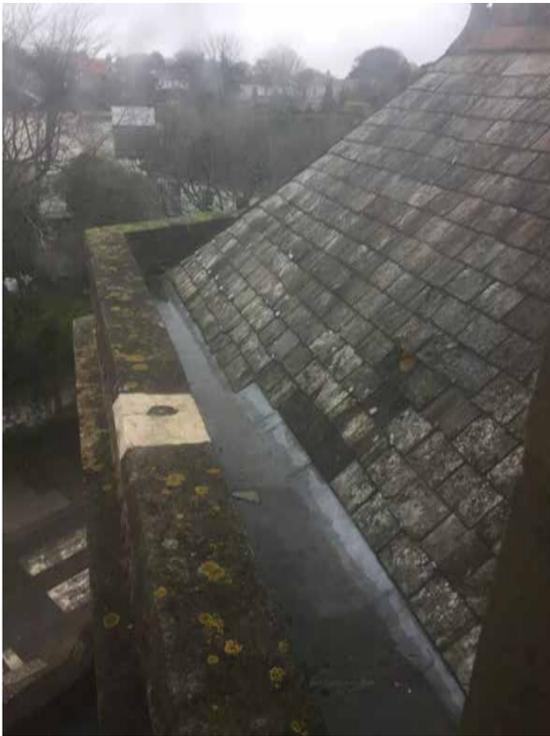
Loose, slipped and cracked slates to the roof have caused water ingress in the past, causing damage to roof timbers and ceiling/wall plasterwork. It is proposed to strip the existing roof slates, re-use as many as possible in re-tiling the roof and introduce breather membranes and insulation to the roof voids to improve the thermal efficiency of the building for the occupiers and users. Lead work will also be renewed to valley gutters and parapet walls.

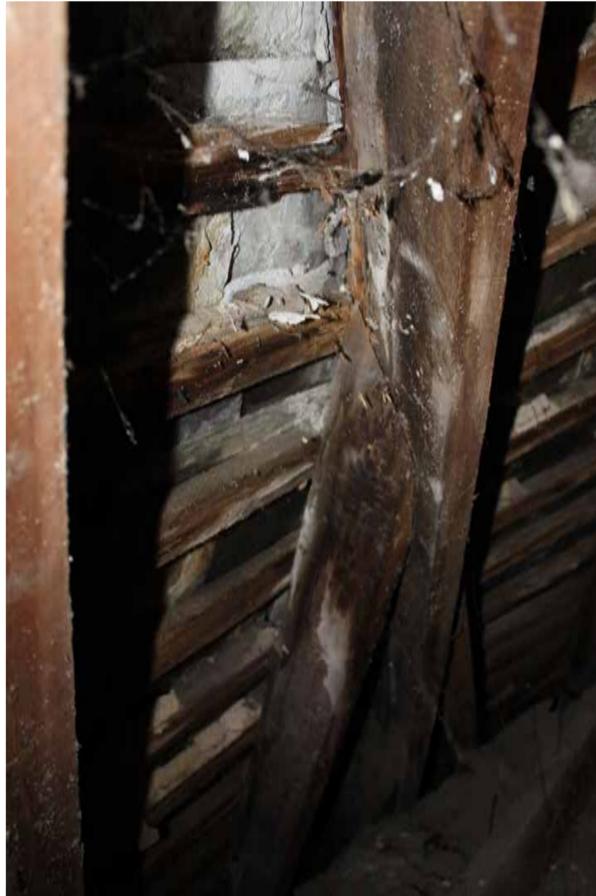
Damage caused to the roof timbers internally through slipped/cracked slates and water penetration will require localised timber repairs/replacements, with the roof space also being treated with a timber preservation solution.

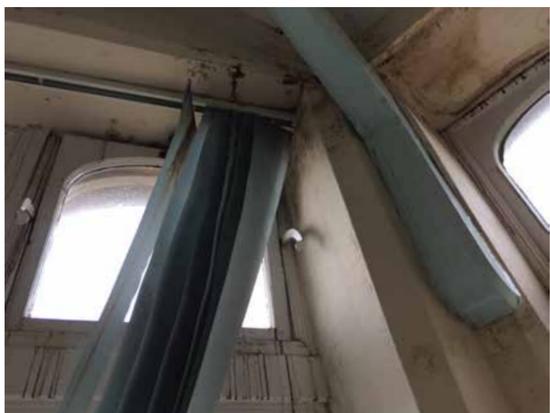
Although existing windows are in fairly sound condition, many require minor maintenance and redecoration. In certain areas of the building, it is proposed to install secondary glazing to improve the thermal efficiency of the building and reduce noise. In other areas, the use of thermal blinds will also assist with retaining heat within the building.

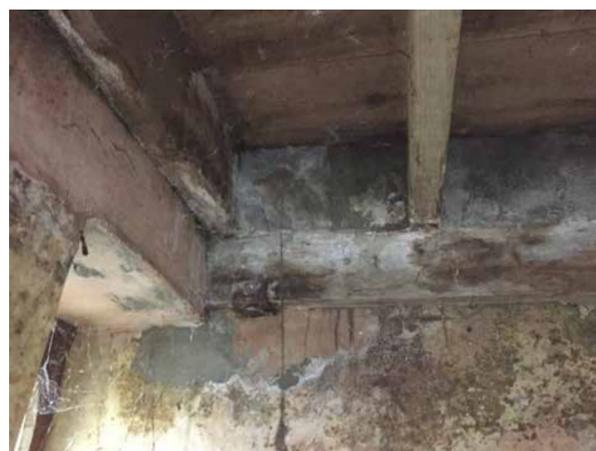
The existing tower roof timbers require replacement, together with the lead covering. Repairs to the roof will allow the reinstatement of the flag pole as in the Architect's original drawings for the building, allowing the Camborne Town Council flag to be prominently located.

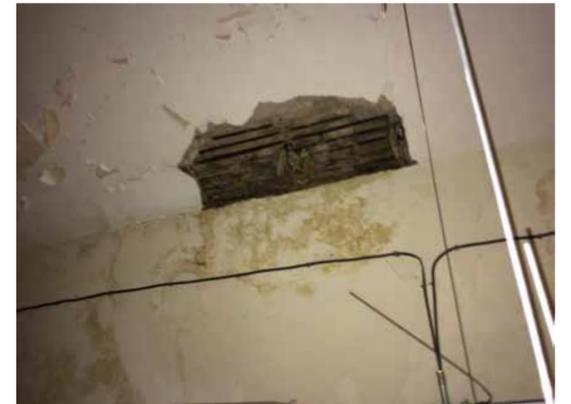
Damaged ceiling and wall plaster work as seen here, is caused by the lead trays to chimneys above failing and allowing water to penetrate the building over a long period of time. All damaged plaster work will be sensitively removed and replaced like-for-like and redecorated.

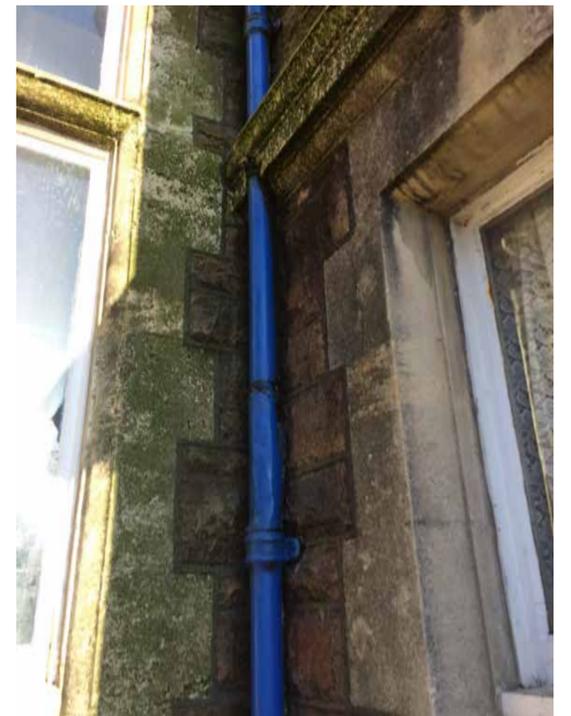
Blocked and damaged rainwater goods lead to water penetrating the building fabric and causing damage to the plasterwork and fittings internally. We propose to replace the existing rainwater goods with cast aluminium heritage range products and increase the sizes to allow for the future effects of climate change.

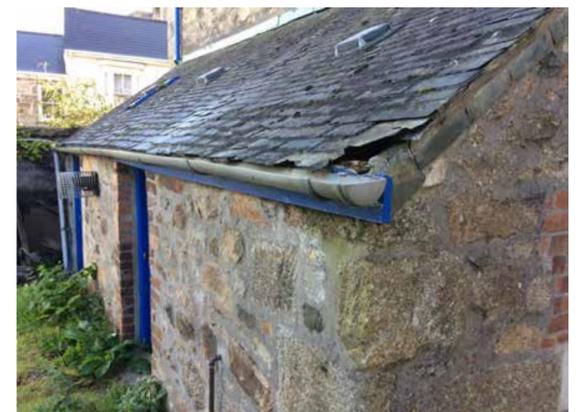
The existing boiler house is in need of repair, with the scantle slate roof failing. As the boiler is to be replaced and upgraded, the boiler house too will be repaired and re-roofed.
